Subject: Report of Current Activities

SELFUSO PREPARED BY	PASADENA	HYCON MFG. COMPANY	CALIFORNIA	PAGE 1 of 4
CHECKED BY <i>AB</i>	DURABILITY TEST HS-732			FOR HS-732
DATE 29 Oct 57	Serial #62			REPORT

PREPARED BY <u>DMT</u>	PASADENA	HYCON MFG. COMPANY	CALIFORNIA	PAGE _____
CHECKED BY _____	PRELIMINARY ENGINEERING REPORT, VIBRATION STUDY 73-B SHUTTER			JOB _____
DATE <u>11-12-57</u>				REPORT _____

PREPARED BY <u>DMT</u>	PASADENA	HYCON MFG. COMPANY	CALIFORNIA	PAGE _____
CHECKED BY _____	VIBRATION DATA CONFIG. 73-B			JOB _____
DATE <u>11-12-57</u>				REPORT _____

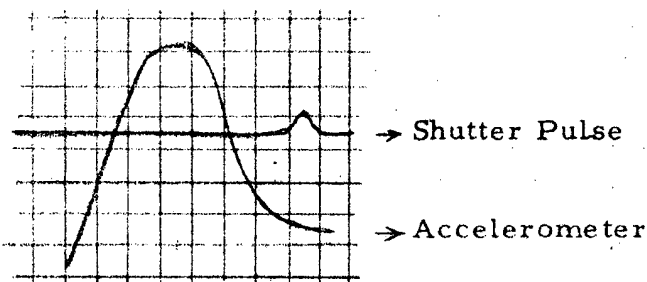
A.

Shutter Transient on Lens Housing, Side to Side.

Remarks: No shock mount.

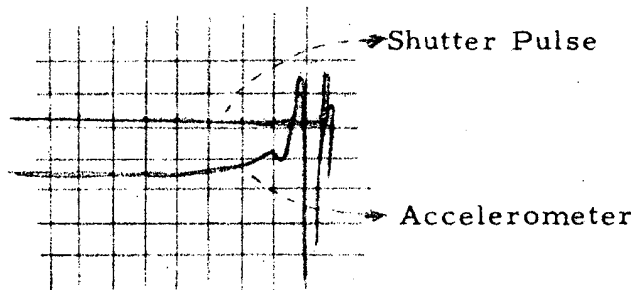
A.

Shutter Transient on Lens Housing, Side to Side.

Remarks: No Shock Mount

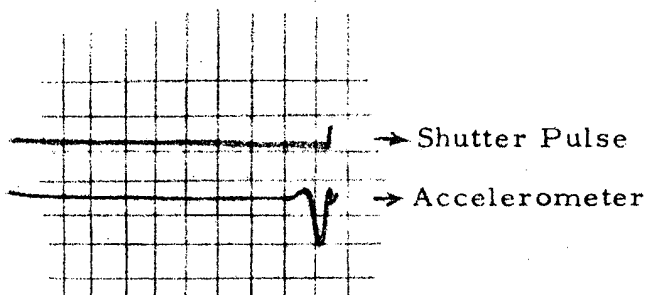
B.

(Indicator reads approx. .005)

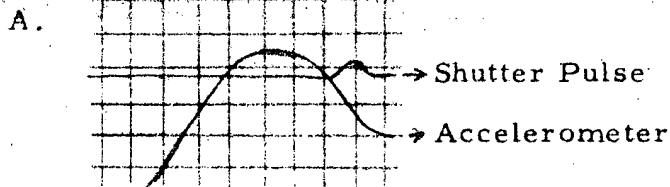
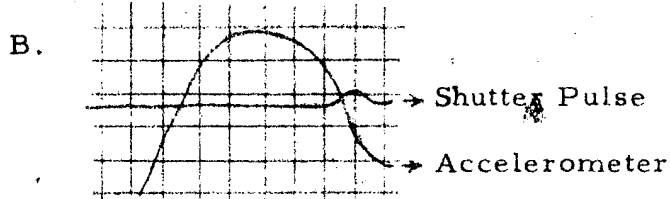
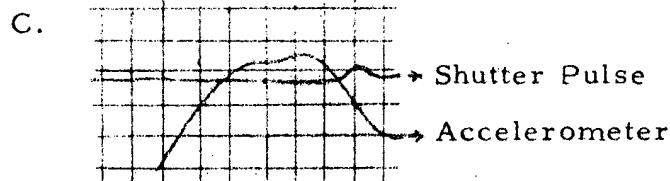
Pick-Up Location: Shutter

Remarks: Shock mounted on soft rubber buttons.

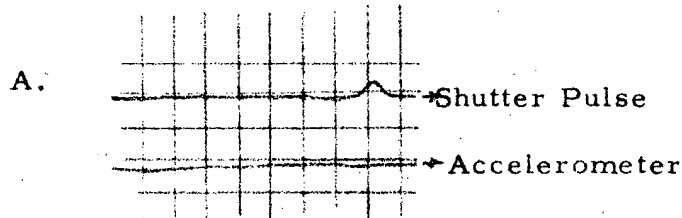
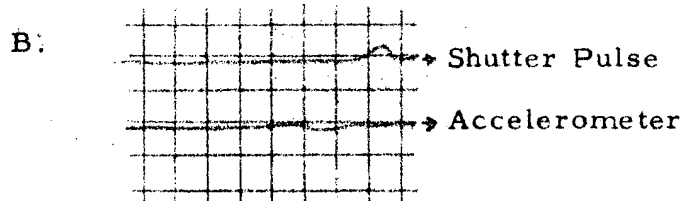
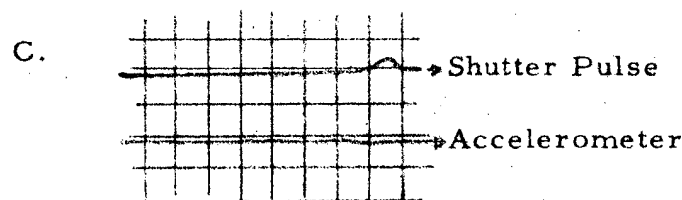
Pick-Up Location: Lens Housing

Remarks: Shutter mounted on rubber buttons.
